GEOLOGICAL AND GEOTECHNICAL INVESTIGATION OF EUREKA BEND, SH60, TAKAKA HILL, NEW ZEALAND

A Thesis

Bachelor of Science with Honours in Engineering Geology

2008

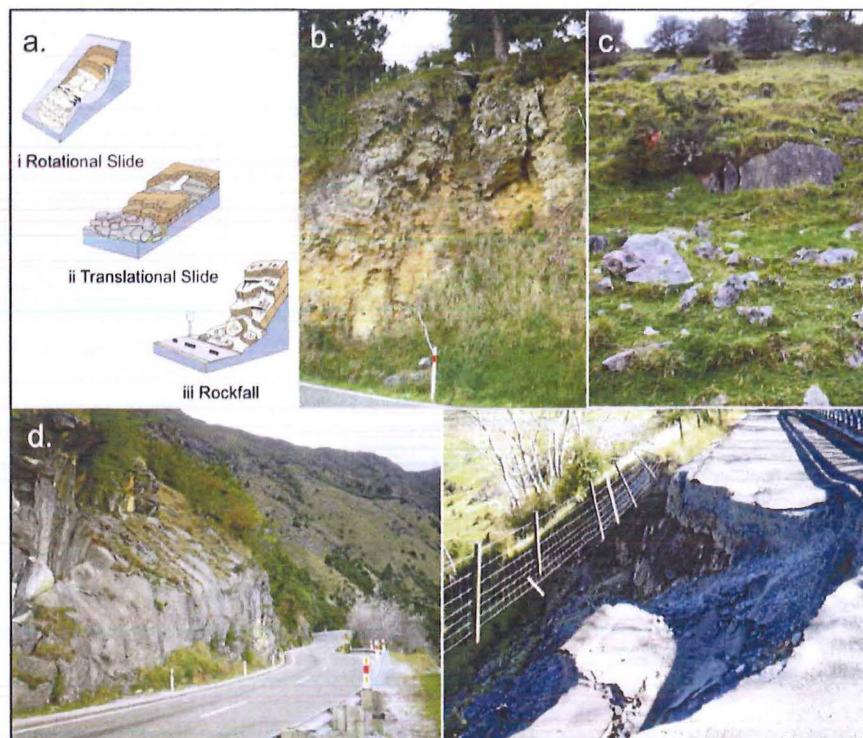
The primary slide failures that can be observed along the Eureka Bend section of SH60 are planar failures within the limestone, and these are generally controlled by bedding that dips steeply towards the road, as shown by Figure 1-3d. Jointing within the limestone also results in small secondary wedge failures, together with the initial planar failure. Rotational failures within the roading fill have also occurred, usually as a result of poor construction practices, such as the current failure that is restricting

traffic to one lane below Eureka Bend (see Figure 1-3e). Remediation measures used include scaling, rock bolting, and wire mesh to reduce the planar failure hazard to the road. Failures within the fill have historically been topped up with extra fill and resealed. Currently there is a Bailey bridge acting as a temporary remedial measure to allow traffic to negotiate the most recent failure within the fill.

A combination of the steep topography and the highly fractured nature of the Arthur Marble high upslope create a potential rock fall hazard to the road (see Figure 1-3c). The semi-spherical shape of the marble blocks means that they will easily begin to roll and the steep terrain allows them to gather a lot of momentum before reaching the road. Occasionally large boulders will cause significant impact damage to the road surface that requires repairs.

Figure 1-3: Examples of various slope failures adjacent to Eureka Bend. a. Failure methods, b. Slump within colluvium, c. Rockfall boulders, d. Planar failure in limestone, e. Rotational failure in fill. (a. is adapted from <<http://pubs.usgs.gov/fs/2004/3072/fs-2004-3072.html>>).

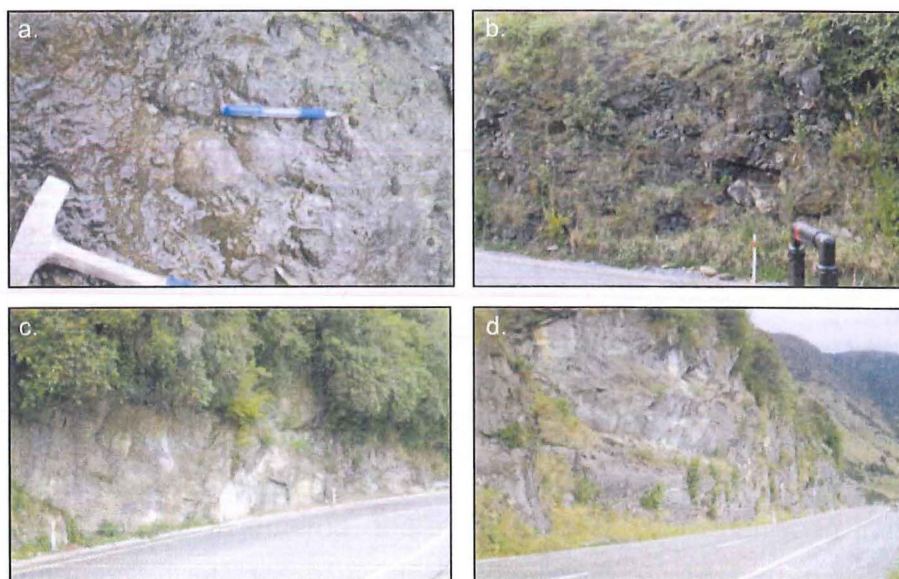
Figure 2-4: Examples of Takaka Limestone.

Just north of Eureka Bend a zone of highly fractured limestone can be observed. Figure 2-4b shows no real sign of structure, and bedding is generally not present within this zone, suggesting that it may have been associated with faulting.

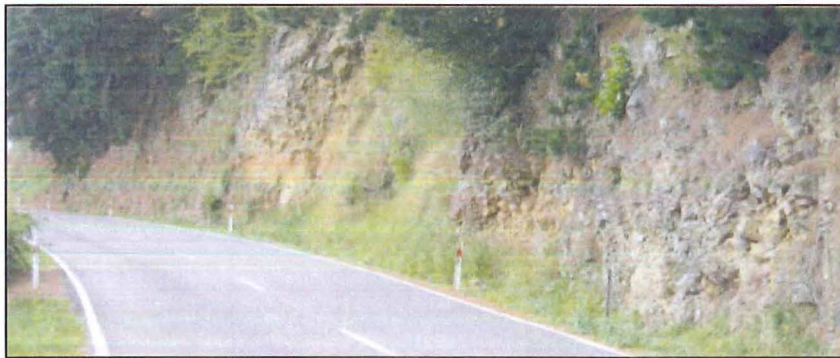
Suficial deposits of colluvium are observed along the road cutting north of Eureka Bend. It appears to be reworked and recalcified breccia that has been transported down slope as a landslide. It consists of clasts of marble and limestone held together by an orange-brown silty fine sand matrix (see Figure 2-5). Thicknesses of about 6m are observed in the road cutting north of Eureka Bend.

Much of the limestone outcrop below the Pisagh Fault and in the road cutting has been obscured due to the nature of the colluvium.

Figure 2-5: Example of colluvium outcropping in road cutting.

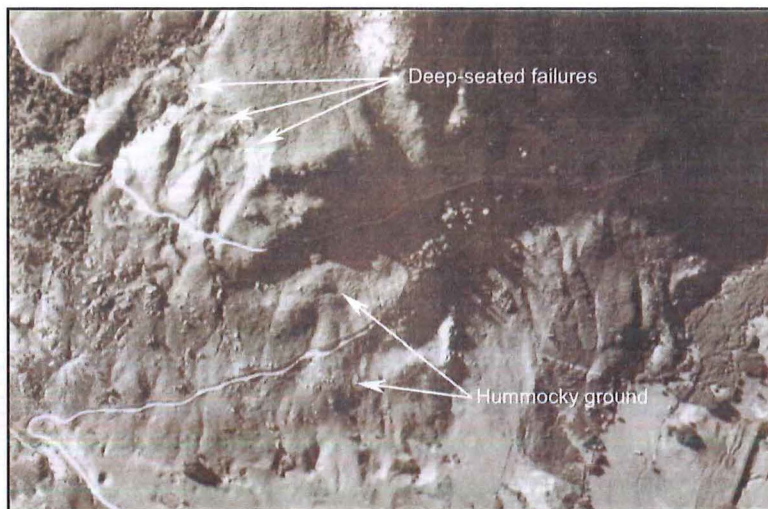
From studies of aerial photography and field investigations three deep-seated failures were indentified within the study area above Pylon Point. The head scarps of all three appear to be connected suggesting that they are located within unstable geology, as shown by Figure 2-6. The origins of the failures are within the brecciated material associated with the Pisagh fault, which may have been the triggering mechanism. They all appear to be rotational landslides in nature meaning that the

failure plane must be within a homogenous medium such as the breccia and not bedrock that would see defect controlled failure surfaces (Cruden and Varnes, 1996).

All three landslides appear to have been subjected to erosional processes for a significant period of time and therefore are believed to significantly pre-date the construction of State Highway 60. The lack of recent movement or tension cracks suggest that the landslides are inactive and are therefore of only minor concern to the ongoing stability of the road.

Figure 2-6: Deep-seated failures and hummocky ground as seen in the 1944 air photo.

There is a zone of hummocky ground that extends downslope from the scarp created by the Pisagh fault to the bottom of the hill (see Figure 2-6). Hummocky ground suggests that the area has been subjected to slope instability in the past and the uneven ground is evidence of this. The most likely source of slope instability is within the marble breccia associated with the Pisagh fault. Reworked breccia (colluvium) along the upper carriageway road cutting north of Eureka Bend provides evidence that the breccia has been subjected to instability in the past, which may have caused large volumes of material to slide down slope thus creating the hummocky ground that is visible both above and below the road.

From field observations there is no evidence to suggest that a mass movement of the slope is likely to occur in the near future. However, the proximity of the proposed failure to the Pisagh fault indicates that the fault may have been the triggering mechanism and any reactivation along the fault may create further instability, which may affect the road.

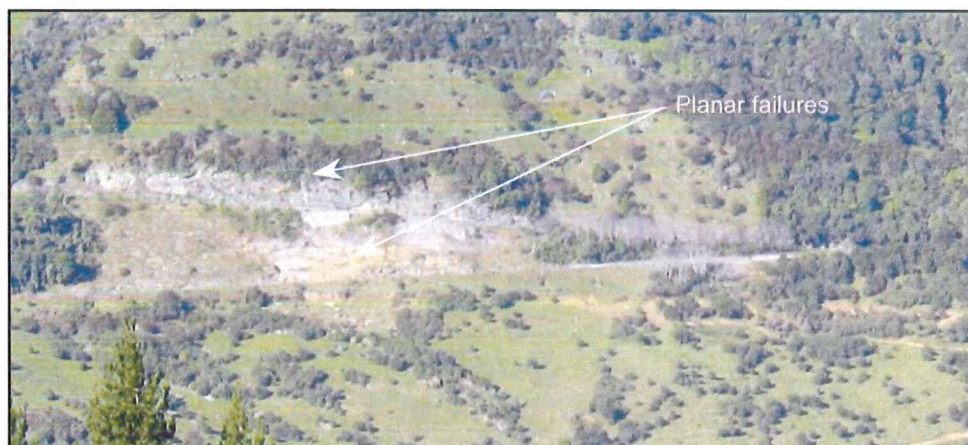
Planar failures along bedding surfaces within the well-bedded limestone can be seen north of Eureka Bend both on the upper and lower carriageway (see Figure 2-7). Here the limestone bedding dips towards the road at around $40 - 50^\circ$ meaning that it is inherently unstable. From aerial photography analysis it is possible to see that the failures had not occurred pre-1944 and even the 1989 photos do not show evidence of failures in this area. Therefore, the likely cause of the failures is related to the widening of the road in the 1950s, which would have removed support from the toe of the slope. The removal of vegetation from the affected slopes post 1989 also removed supporting roots that would have bound the blocks together.

Under the correct conditions such as increased pore water pressure due to heavy precipitation, or seismic shaking, there is a high possibility that further planar failures will occur along this section of the road.

Figure 2-7: Planar failures above the upper and lower carriageways north of Eureka Bend.

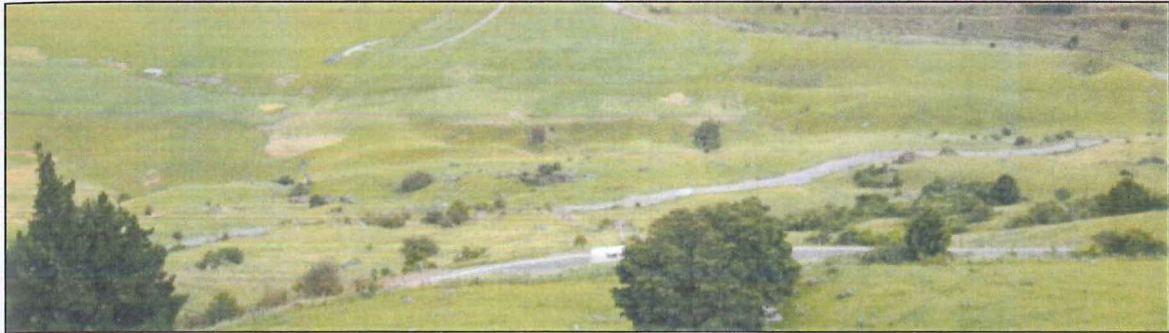
Karst terrain is evident in the study area as sink holes both within the limestone at the base of the hill and the marble breccia above the road. Dissolution and collapse of the underlying limestone and marble when it comes in contact with water has created the undulating terrain that is seen at the base of the hill (see Figure 2-8).

Figure 2-8: Sinkholes within karst terrain at the base of the hill.

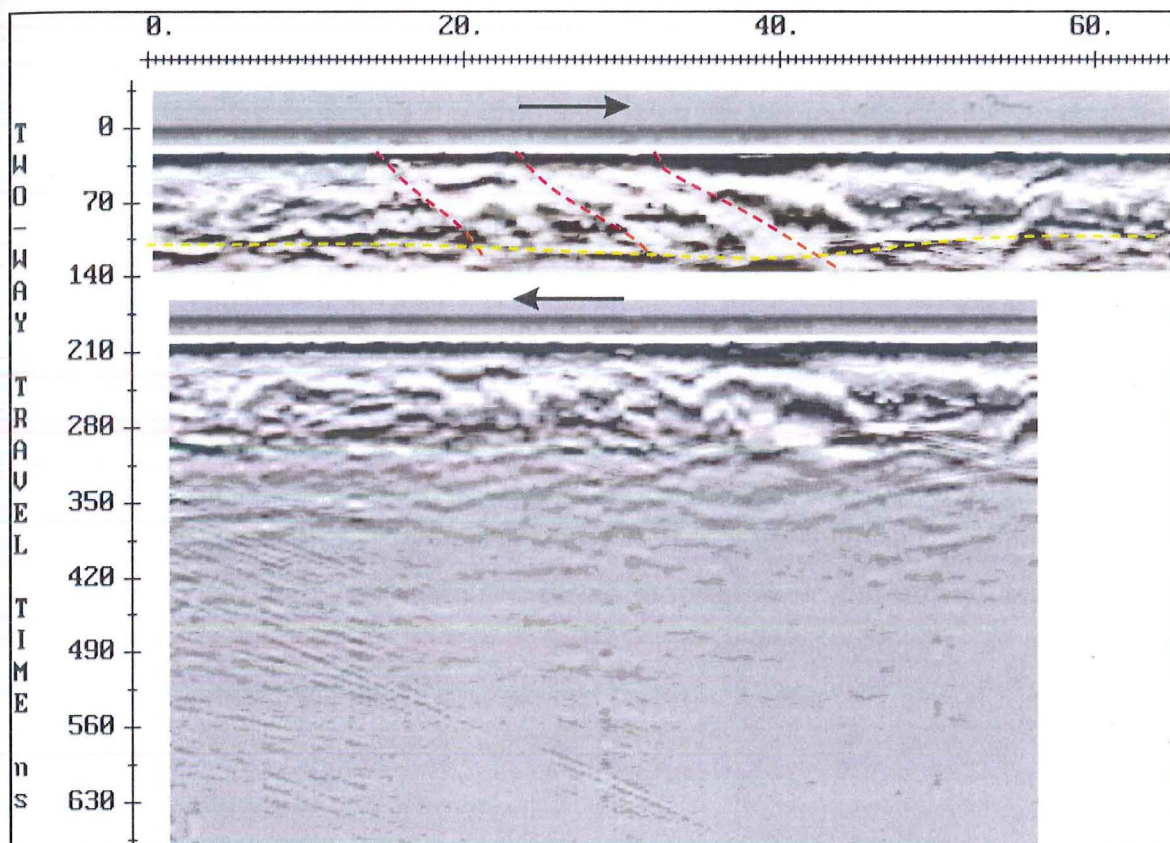
The top part of Figure 3-5 shows the data that was collected during the uphill traverse. From this data it is possible to see a series of joints that when corrected for a 35° - 40° slope will appear sub-horizontal. A subhorizontal layer is also seen within the data, and it is possible that this is a bedding plane within the limestone because again when the data is corrected for topography it will appear sub-parallel to the surface with a similar orientation to the bedding that is observed in the road cutting to the north.

Figure 3-5: Data collected during GPR survey at Eureka Bend.

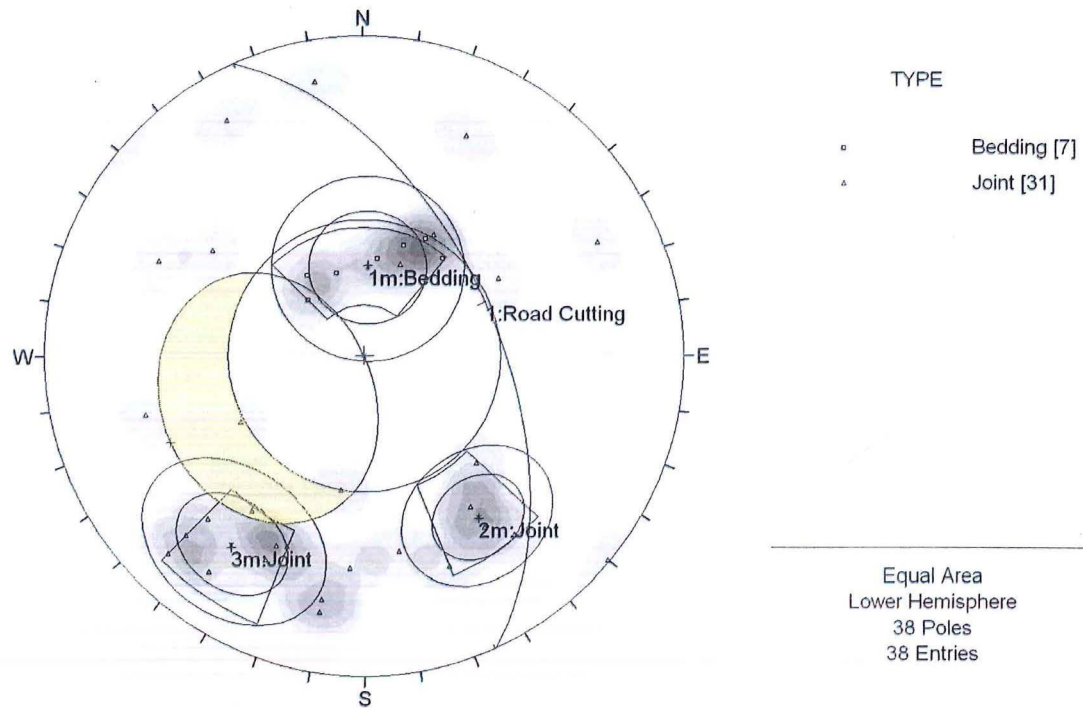
surface and is unlikely to promote further instability of the face or cause more than an inconvenience to roading crews who have to clean it up.

Figure 4-4: Kinematic analysis of road cutting for planar failure potential. Internal angle of friction equals 35° . The yellow zone encompasses poles that have the potential to fail.

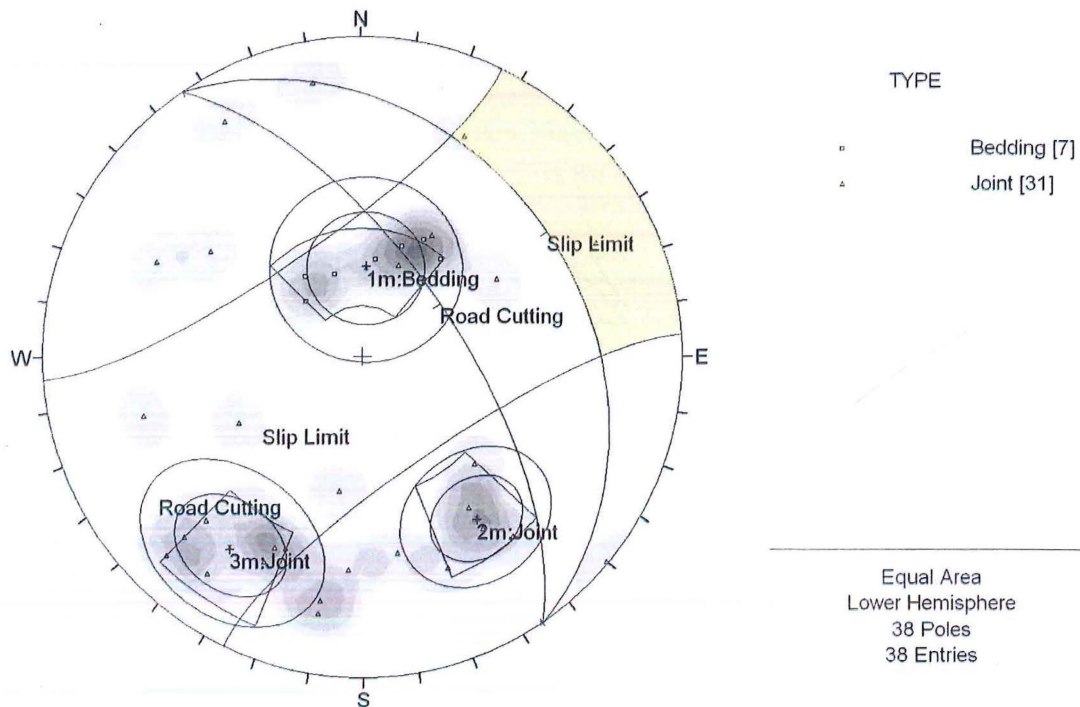
only two poles have plotted within the failure envelope. This may just result in raveling of the face as small pieces of limestone detach from the face. No larger joints sets are likely to cause significant toppling failures.

Figure 4-5: Kinematic analysis of road cutting for toppling failure potential. Internal angle of friction equals 35° . The yellow zone encompasses poles that have the potential to fail.

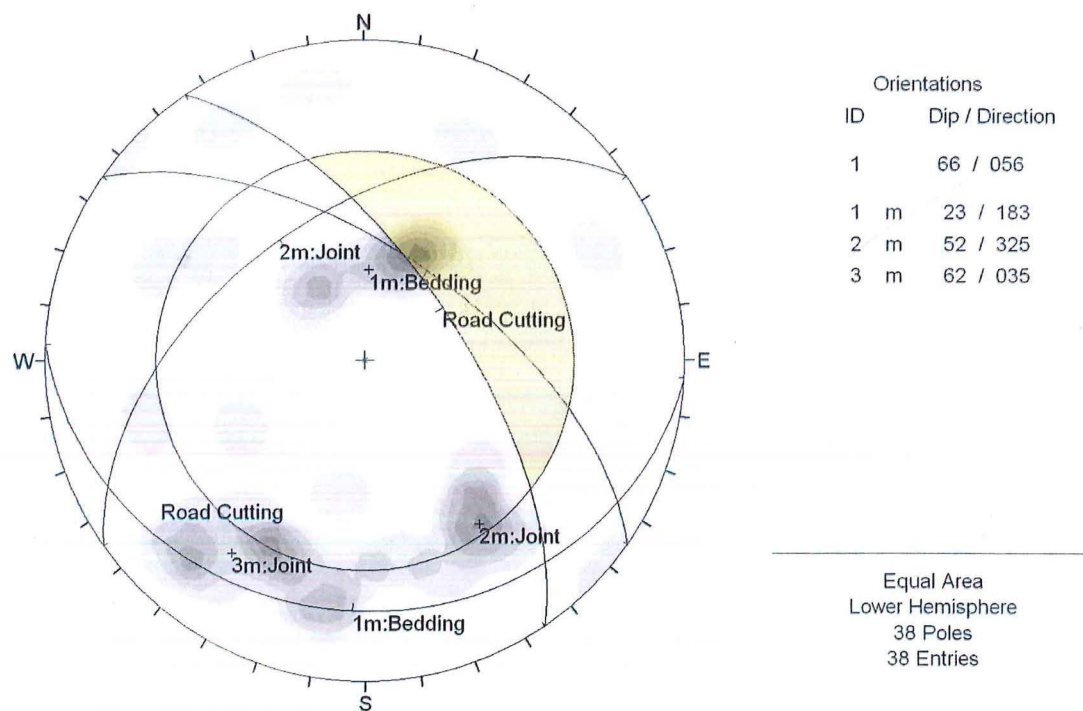
The yellow crescent shown in Figure 4-6 indicates the area on the stereoplot that is prone to wedge failure. If any two planes to defects intersect within this zone then there is a possibility of wedge failure. As no planes to bedding or joints intersect within this zone the face can be considered stable. There may still be the possibility of small-scale wedge failures occurring along defect intersections that were considered too insignificant to include in a joint set or were sub-parallel to face.

Figure 4-6: Potential for wedge failure in defects in the road cutting.
The yellow zone encompasses intersections of planes that have the potential to fail.

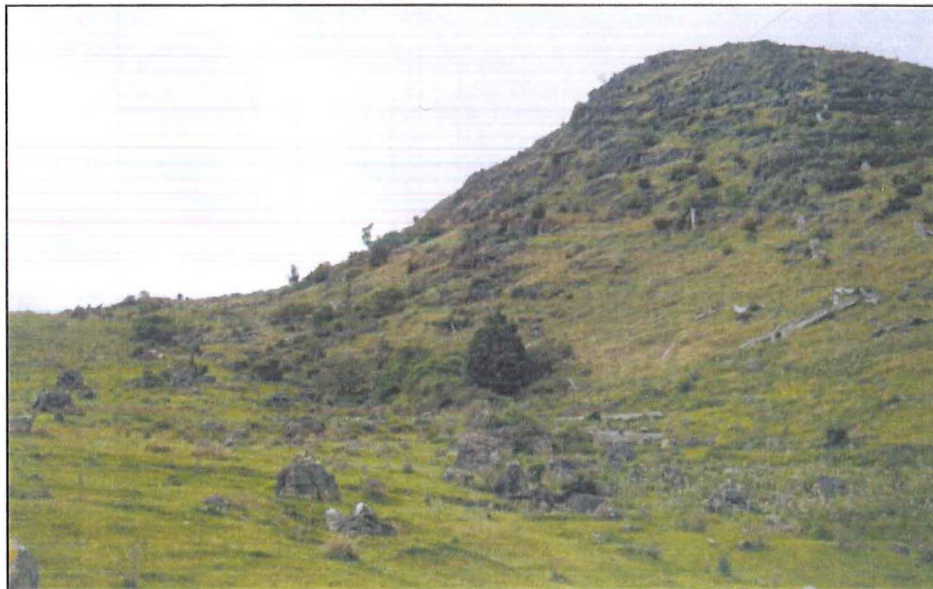
The highly fractured and semi-spherical nature of the marble higher upslope means that the road and motorists using it may be at risk from rockfalls. The lower slopes adjacent to Eureka Bend show evidence of previous rockfalls in the form of rocks that have rolled down from further upslope, as shown by Figure 4-7. There is the potential that one of these rocks may impact on the roadway, therefore a rockfall hazard assessment of the current alignment of Eureka Bend was done using the Colorado Rockfall Simulation Program (CRSP) to determine the susceptibility of the current roadway to rockfall hazards from boulders released higher upslope. The rockfall parameters that were used were obtained from the user manual written by Pfeiffer *et al.* (1995).

Figure 4-7: Evidence of previous rockfalls north of Eureka Bend

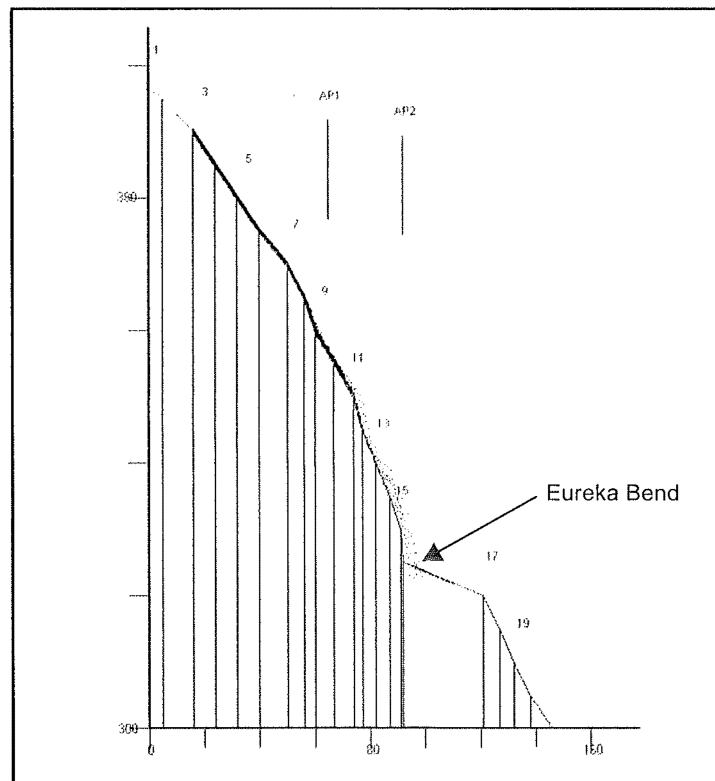
in reducing the number of rocks passing, from 36 at Analysis Point 1 to just 10 at Analysis Point 1, however although the probability of a rock reaching the roadway is low it is still obviously feasible and careful management of the vegetation is needed to provide protection from rockfall hazards. Additional mitigation measures may be deemed necessary as they could be incorporated into the planned widening.

Figure 4-8: Output from CRSP for current profile at Eureka Bend.
AP = Analysis Point. Vertical exaggeration 1V : 2.7H.

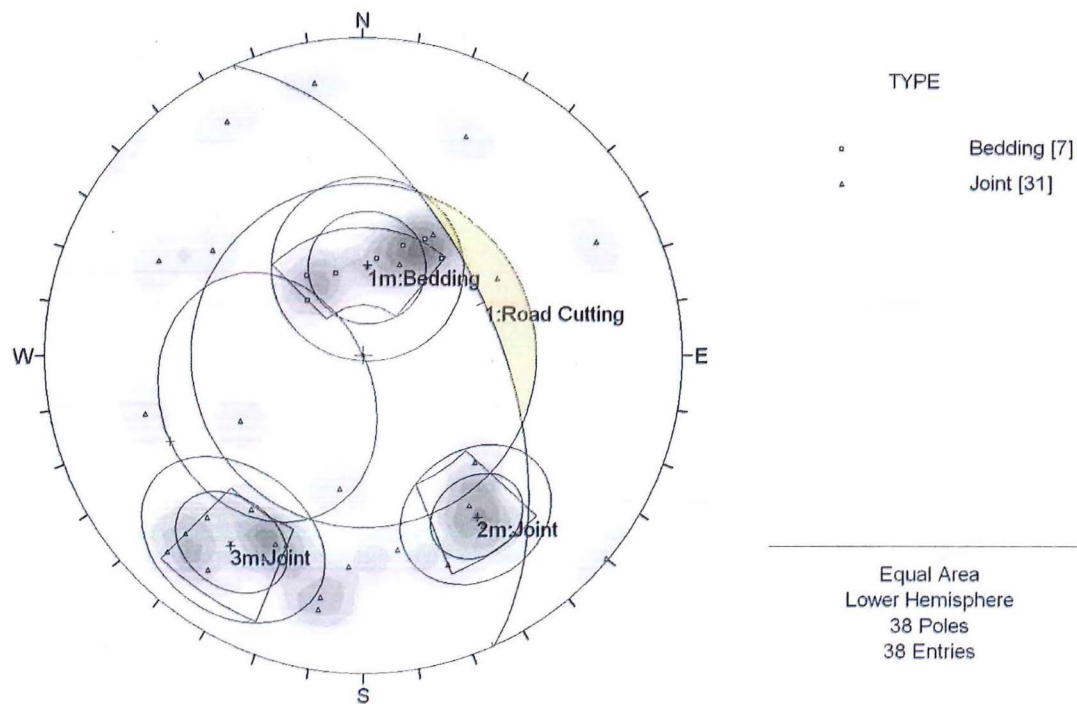
Appendix 3-1: Potential for planar failure along defects road cutting is in its current orientation. The yellow zone encompasses poles that have the potential to fail. Angle of internal friction equals 45° . Clearly there is a very low chance of planar failure as only one pole plots within the failure envelope.

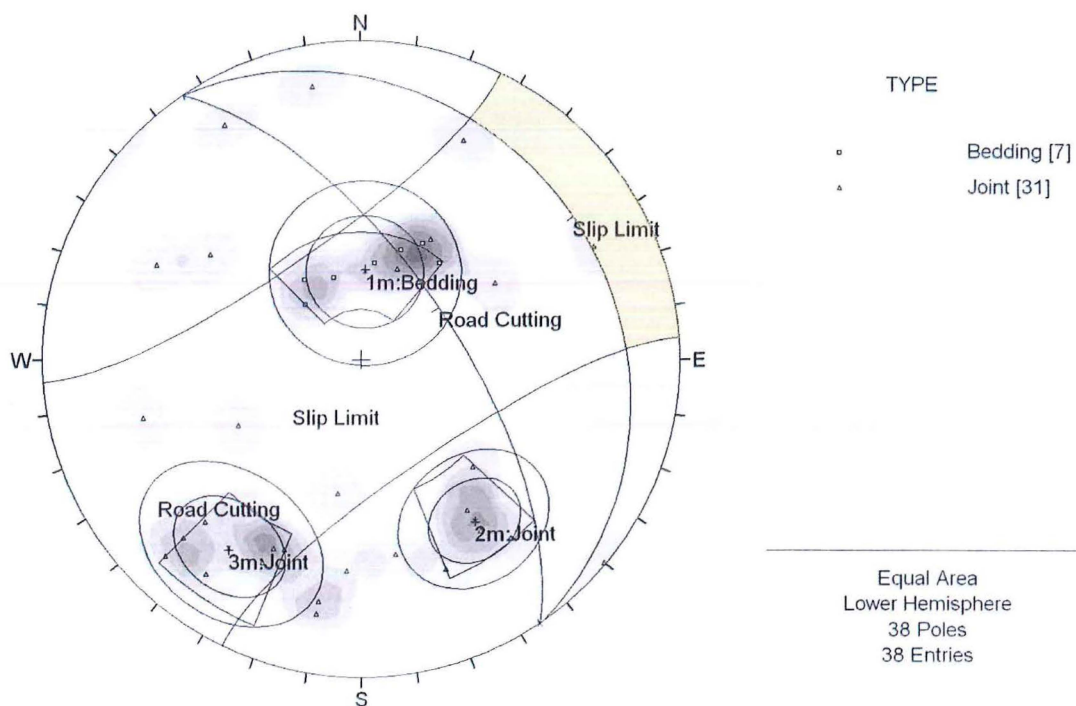
Appendix 3-2: Potential for toppling failure along defects road cutting is in its current orientation. The yellow zone encompasses poles that have the potential to fail. Angle of internal friction equals 45° . Clearly there is a very low chance of toppling failure as only one pole plots within the failure envelope.

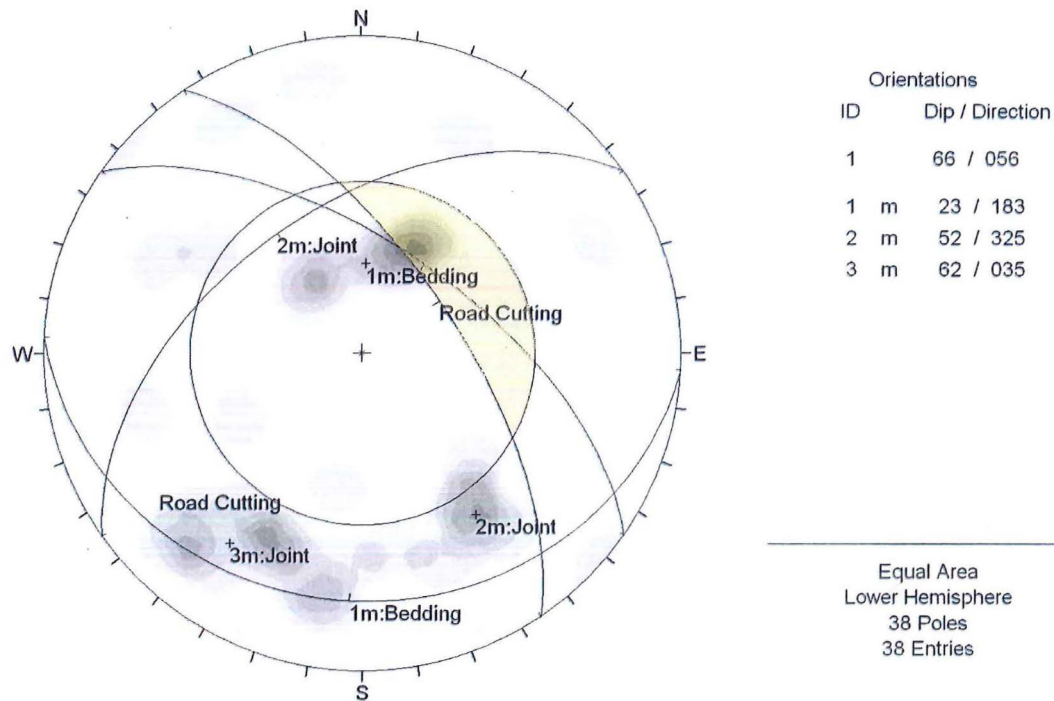
Appendix 3-3: Potential for wedge failure along defect intersections on the current road cutting orientation. The yellow zone encompasses intersections of planes that have the potential to fail. The angle of internal friction equals 45°. Because no defect planes intersect within the failure envelope the probability of a wedge failure occurring is low.
